PRD-625 Service Instructions

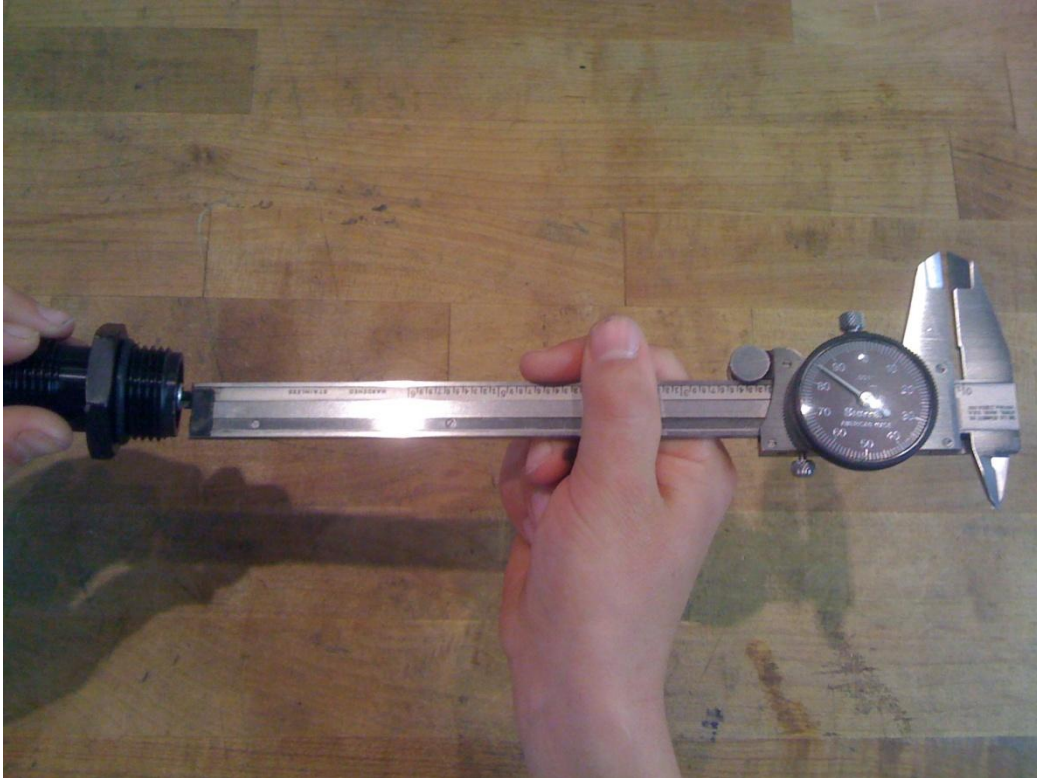
1. Remove the PRD from the Regulator Body by loosening with a 1-3/8-in wrench.
2. Measure and record the distance from the end of the Plunger Stud to the face of the 7/16-in Nut using dial calipers. See Figure 1.

Warning! When disassembling and re-assembling the PRD, 7/16-in nut must be relocated in the same position (depth wise) that it was removed from. Failure to do so will change the pressure setting at which the device vents. This can render the PRD inoperable. An inoperable PRD may result in catastrophic failure of downstream components causing injury or death.

1. Unscrew PRD Stem from PRD Cap using a 3/16-in and 1/2-in wrench.
2. Remove damaged Seat and discard.
3. Install new Seat in PRD Cap.
4. Install and tighten Plunger Stem in Plunger Cap.
5. Coat new area of Stem that rides in housing guide with Krytox or similar oxygen compatible lubricant.
6. Insert Stem Assembly into PRD Housing
7. Insert Spring into PRD Housing.
8. Place Spring Retainer on Spring, flat side out.
9. Compress Spring/Retainer so that 7/16-in Nut can be started on Stem threads.
10. Using ½-in socket and 7/16-in wrench return Nut to original axial position.
